**State of Alaska**  
**Department of Transportation & Public Facilities**

**CATEGORICAL EXCLUSION DOCUMENTATION FORM**  
**FOR FEDERAL HIGHWAY ADMINISTRATION PROJECTS**

**Project Name:** S. Tongass Highway Deermount to Saxman Widening and Saxman to Surf Street Pavement Rehabilitation

# Hydrologic and Hydraulic Report

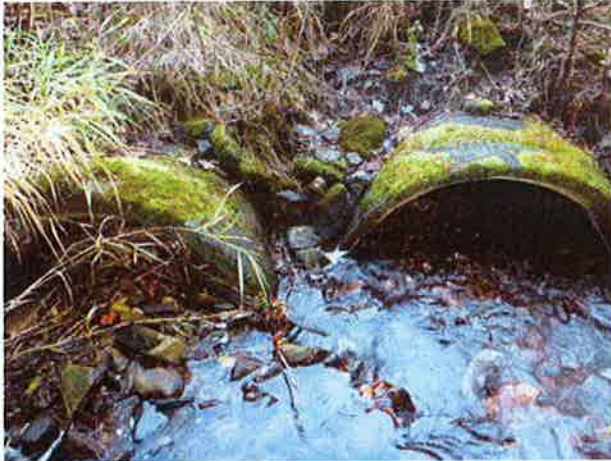
Inlet: Flow directed toward north barrel (photo right) as south barrel is clogged.

**Preliminary Recommendation:** Replace with 48-inch arch pipe single-barrel culvert and raise culvert inverts.

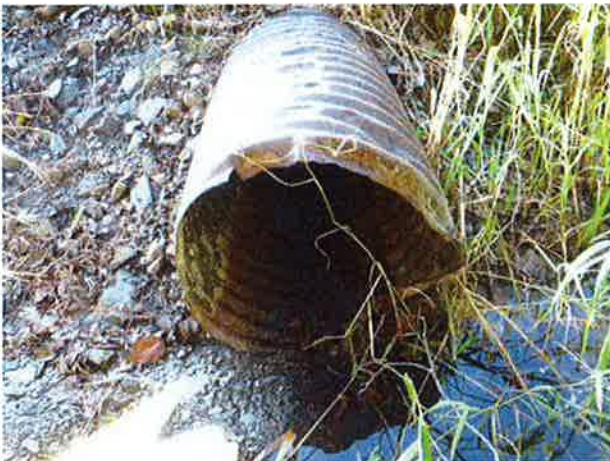
Inlet with corrosion and damage.

**Preliminary Recommendation:** Possibly abandon, and direct flow via ditch to south. Connect with culvert at Station 70+21.

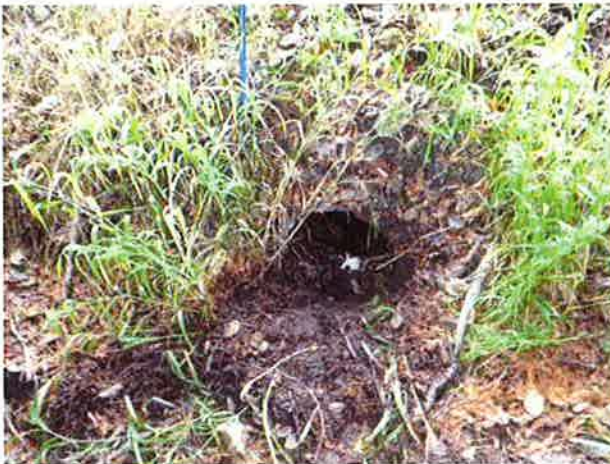
Inlet partially buried and corroded.

**Preliminary Recommendation:** Replace with 24-inch HDPE culvert. Drainage needed to convey water from seep. Direct additional flow from ponding associated at Station 75+88.

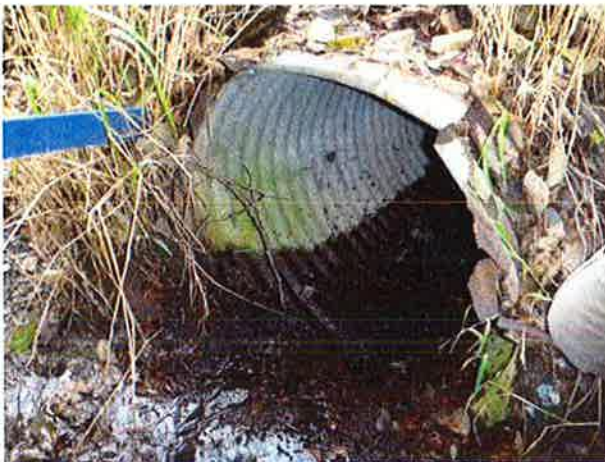
Inlet. Corroded invert.

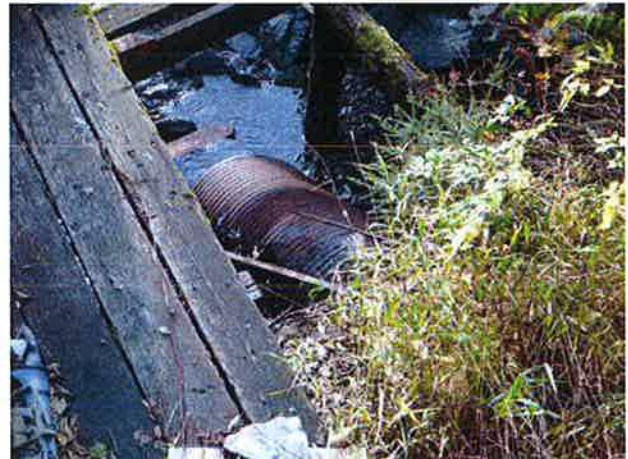
Outlet, structures surrounding with severe degradation of culvert visible. Outlet has steeper slope than inlet.

**Preliminary Recommendation:** Replace with single barrel HDPE culvert, same capacity as existing.

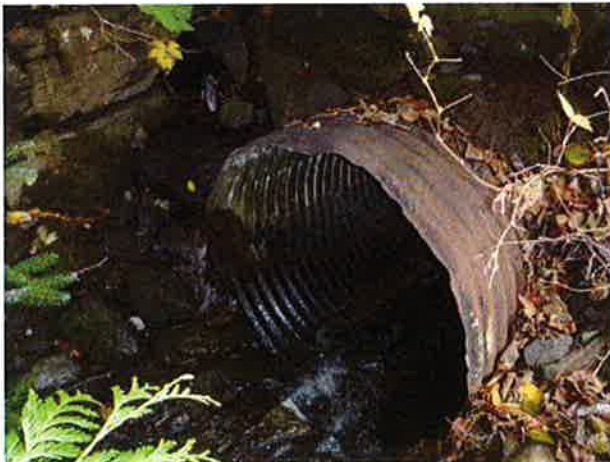
Inlet with corrosion.

**Preliminary Recommendation:** Initially, the site was identified by ADF&G (Site 10103145) as fish habitat for anadromous species, though no fish were observed during the inspection by ADF&G as stated in the inspection report. After HDR's field inspection, Mark Minnillo of ADF&G stated that this site was not an anadromous stream in a letter dated May 11, 2016. Replace with 48-inch HDPE culvert.

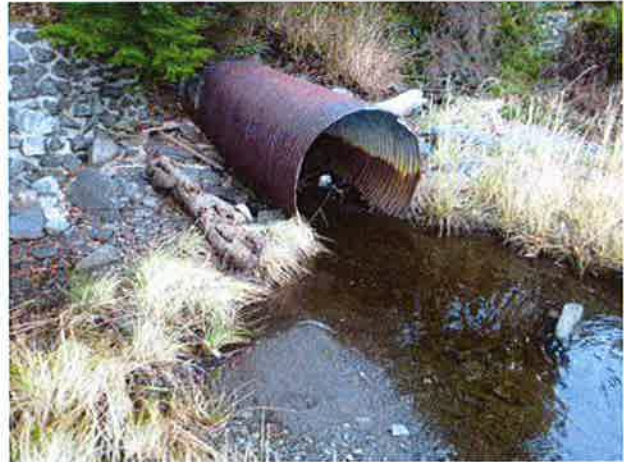
Outlet at high tide line, invert corroded away.

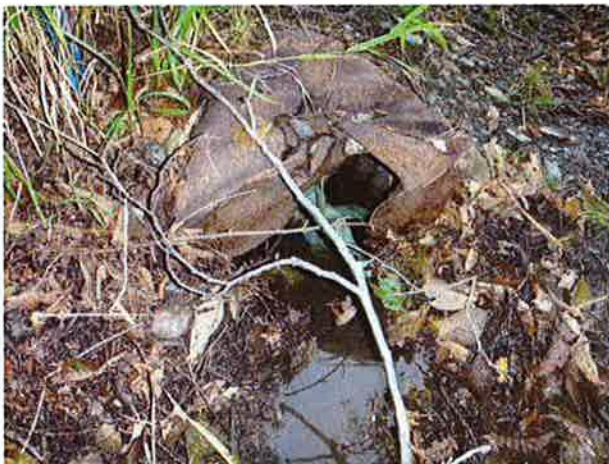
Crushed and corroded inlet.

**Preliminary Recommendation:** Move north ~30 feet to Station 97+18, use 24-inch HDPE culvert. Slope ditches to drain seep.

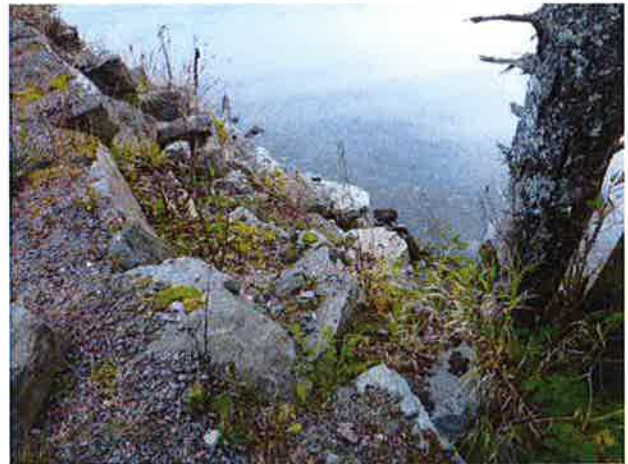
Rock retaining wall and fill have likely buried the outlet, as it was not found.

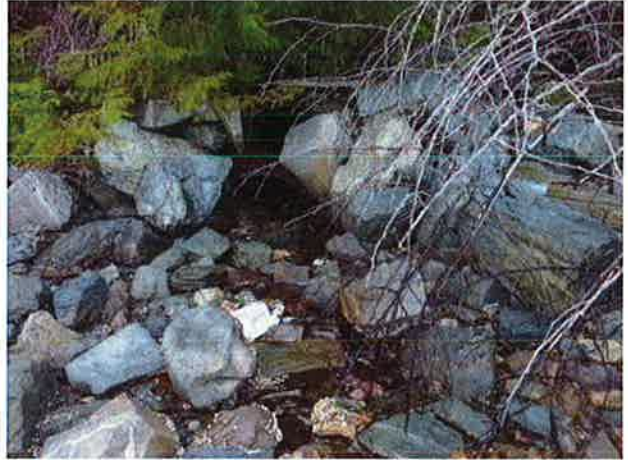
Outlet corroded and damaged.

**Preliminary Recommendation:** Replace with 48-inch HDPE culvert.

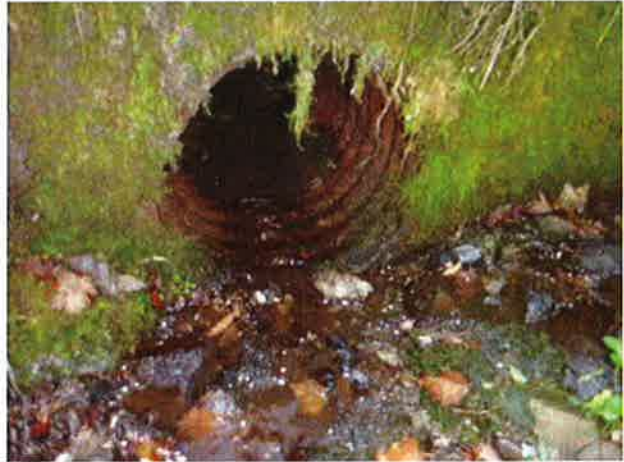
Concrete headwall at inlet. Note invert missing from culvert.

**Preliminary Recommendation:** Replace with 24-inch HDPE culvert.

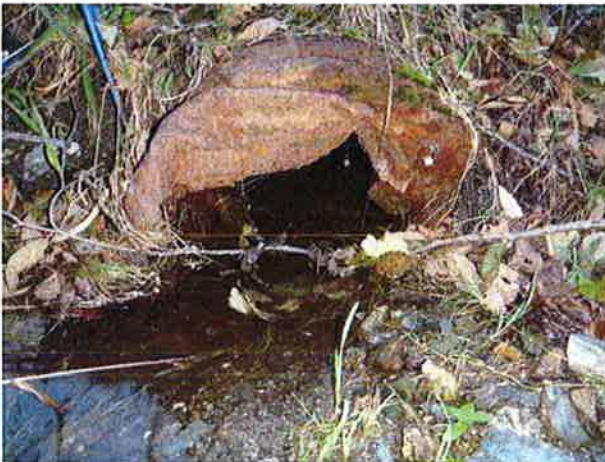
Damaged and corroded inlet.

**Preliminary Recommendation:** Replace with 24-inch HDPE culvert.

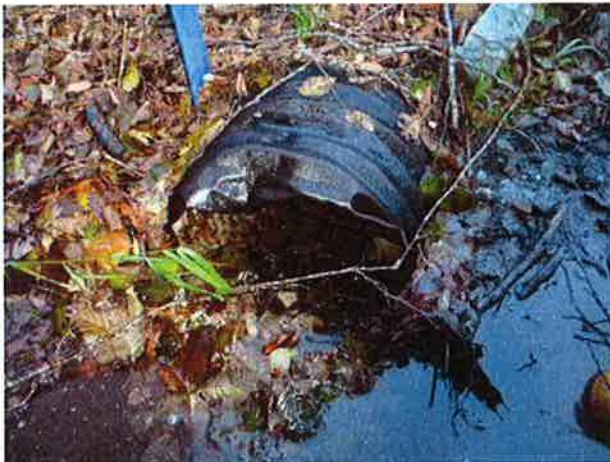
Inlet with standing water. Could indicate culvert failure and water moving through road base.

**Preliminary Recommendation:** Replace with 24-inch HDPE culvert.

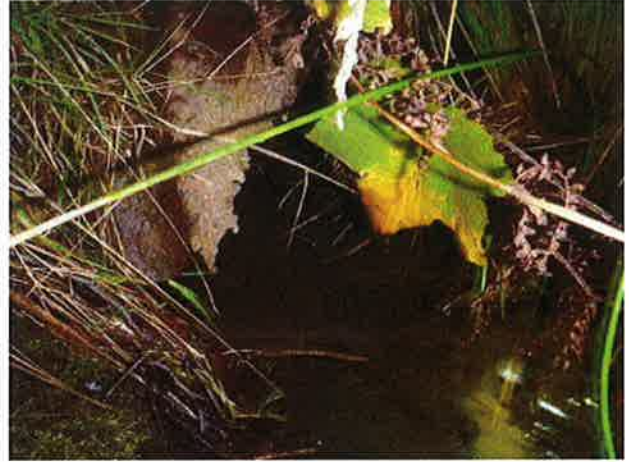
Close-up of inlet, severe corrosion visible.

**Preliminary Recommendation:** Replace with 24-inch HDPE culvert.

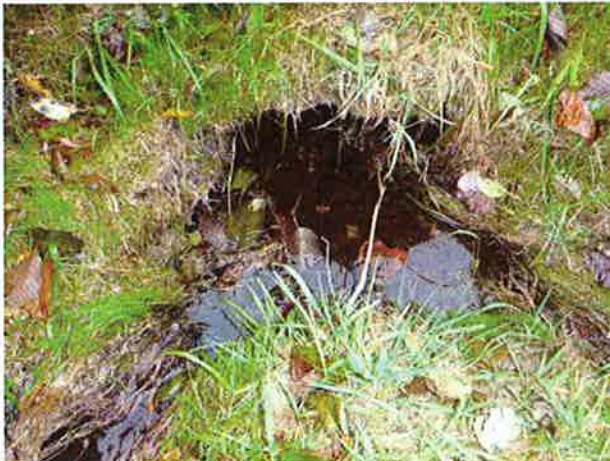
Inlet overgrown and partially buried.

**Preliminary Recommendation:** Replace with 24-inch HDPE culvert.

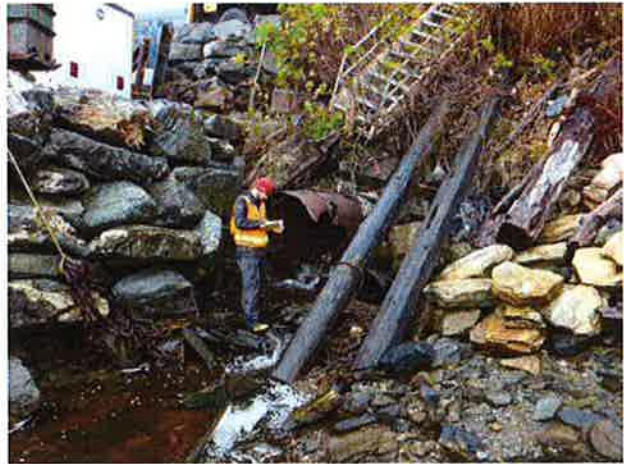
Outlet. Highly corroded with pilings and debris nearby.

**Preliminary Recommendation:** Replace with 48-inch HDPE culvert.

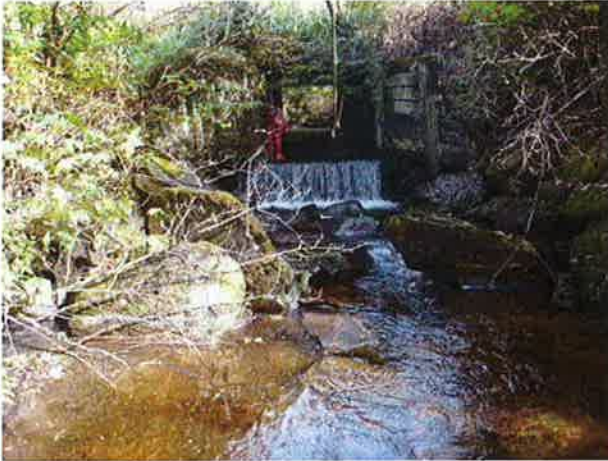
Outlet is a fish passage barrier with 3 feet between the invert and water surface downstream.

**Preliminary Recommendation:** Replace structure, box culvert without invert on sills. Match stream grade through structure by creating pool drops; 20-foot-long pools with 1-foot drops.

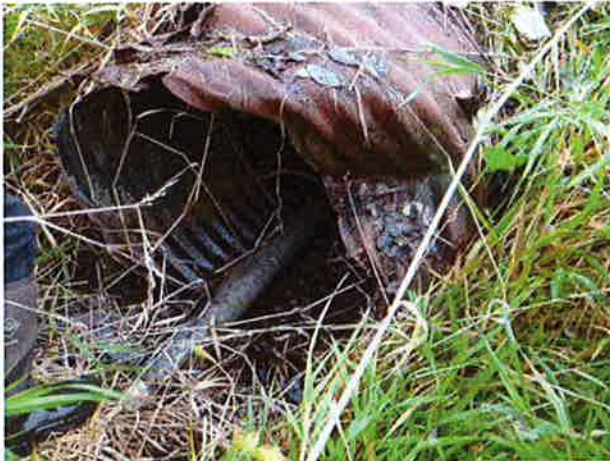
Inlet. Damage and corrosion present with 4-inch steel pipe running through culvert.

**Preliminary Recommendation:** Replace with 36-inch HDPE culvert.

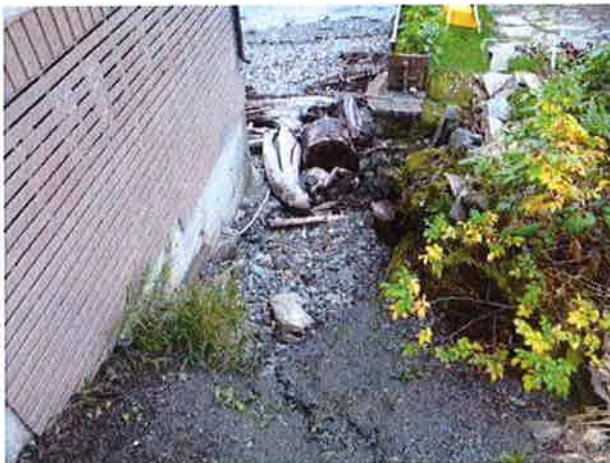
Outlet discharging adjacent to house foundation.

**Preliminary Recommendation:** Replace. Increase to 24-inch HDPE culvert. Grade ditches to south to convey additional flow when culvert at Station 158+96 is abandoned.

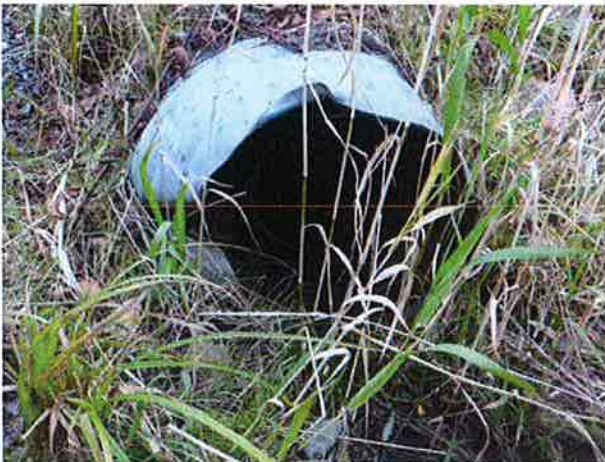
Inlet damaged.

**Preliminary Recommendation:** Replace with HDPE culvert. Increase to 24 inches. Move alignment of culvert to south by 10 feet to avoid damage to rock wall shown in images below. Will accumulate additional flow from abandoned culvert at Station 162+90.

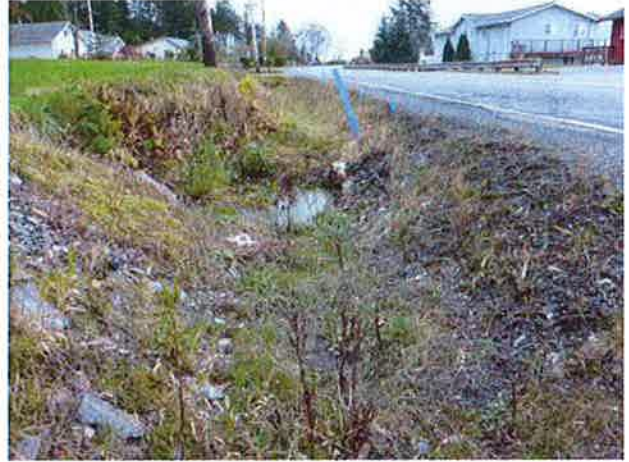
Inlet and ditches to south. Erosion and evidence of backwater at inlet visible.
