STATE OF ALASKA DOT&PF

**STATEWIDE MATERIAL SITE
INVENTORY, SITE INSPECTIONS &
GEOLOGICAL INVESTIGATIONS**

**HARD AGGREGATE
SOURCE LOCATION STUDY**

**FEDERAL PROJECT NO. STP-000S(823)
AKSAS PROJECT NO. 76149**

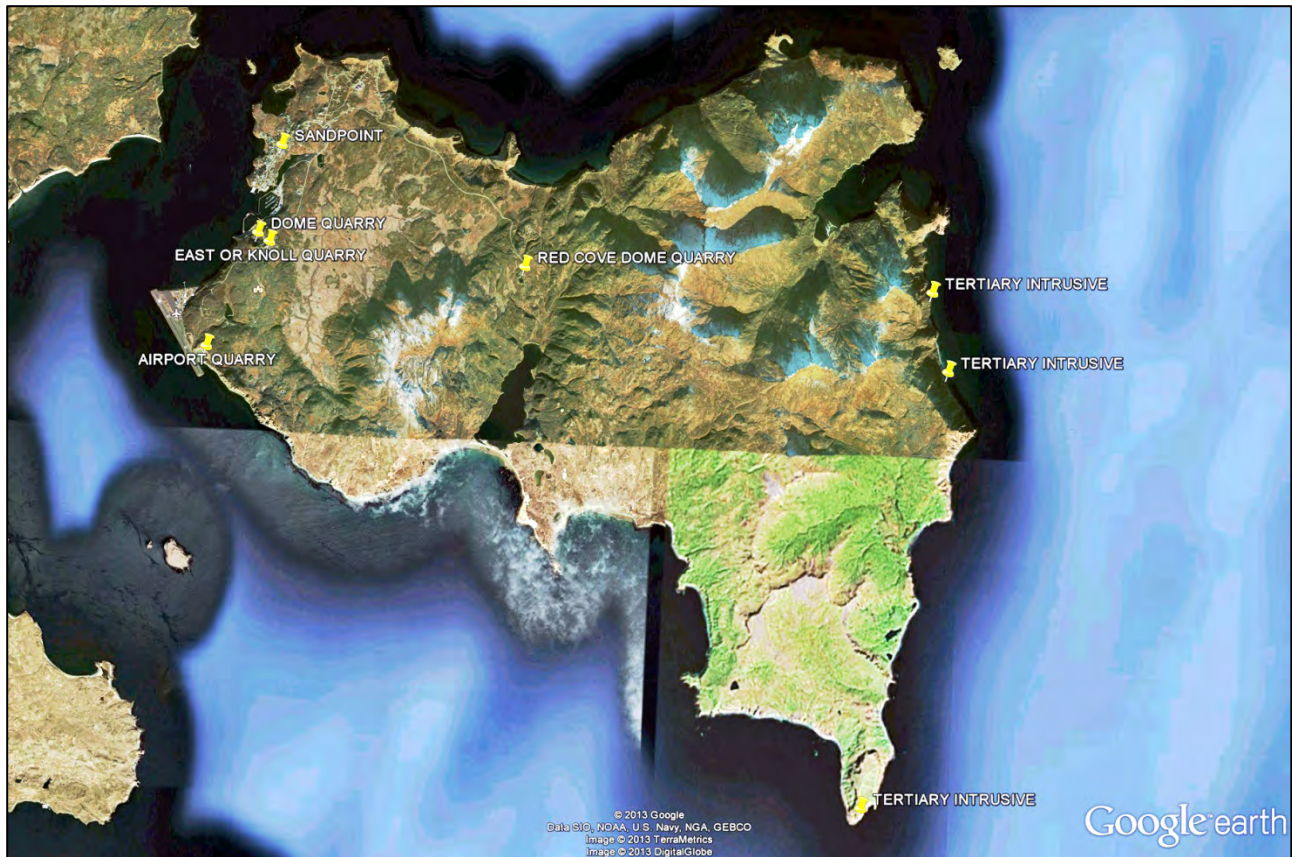
**FIGURE 5 - 5
POPOV ISLAND AND SAND POINT**

The Shumagin Islands are located to the southeast of Sand Point and consist primarily of the sedimentary Shumagin Formation and Tertiary granitic plutons. Minor hornfels were reported on the islands (Wilson et. al, 1995). The difficulty of access, and being in the Alaska Peninsula Unit of the Alaska Maritime National Wildlife Refuge make this an area of low potential for hard aggregate.

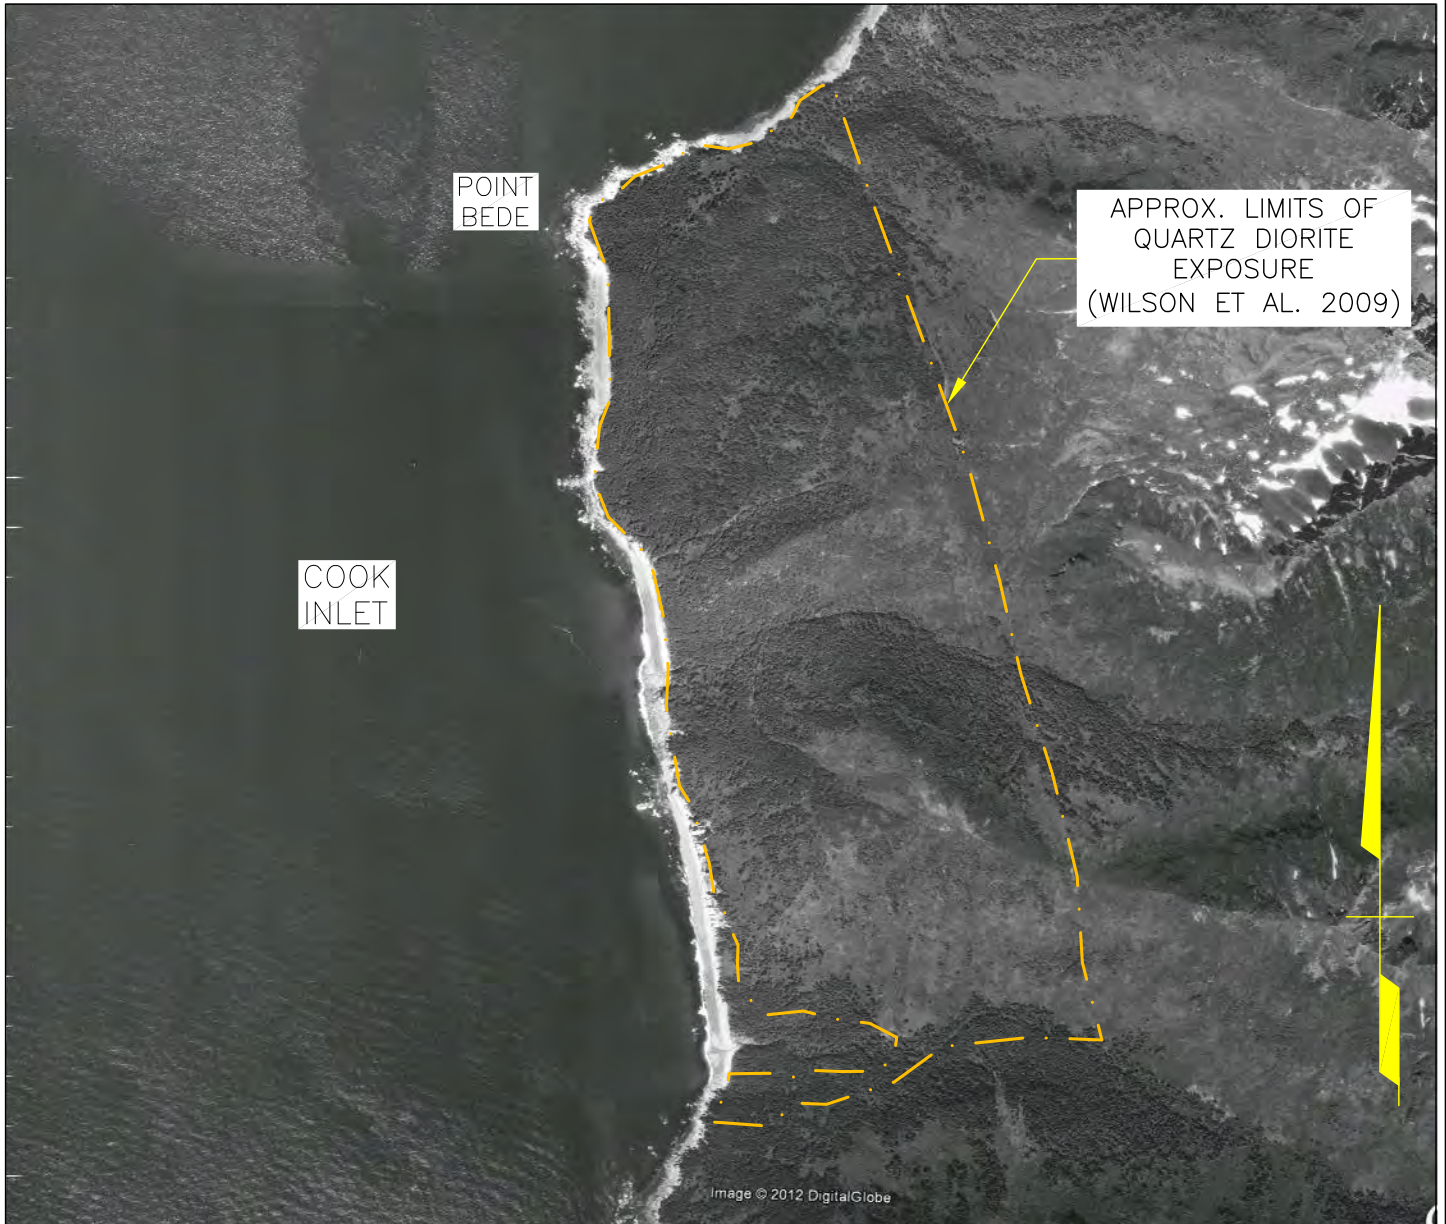
SITE MAP (HA-B1)

BASE MAP IS JUNE 25, 1997 U.S.G.S. AERIAL PHOTOGRAPHY.
THIS IS A PLANNING DOCUMENT ONLY.

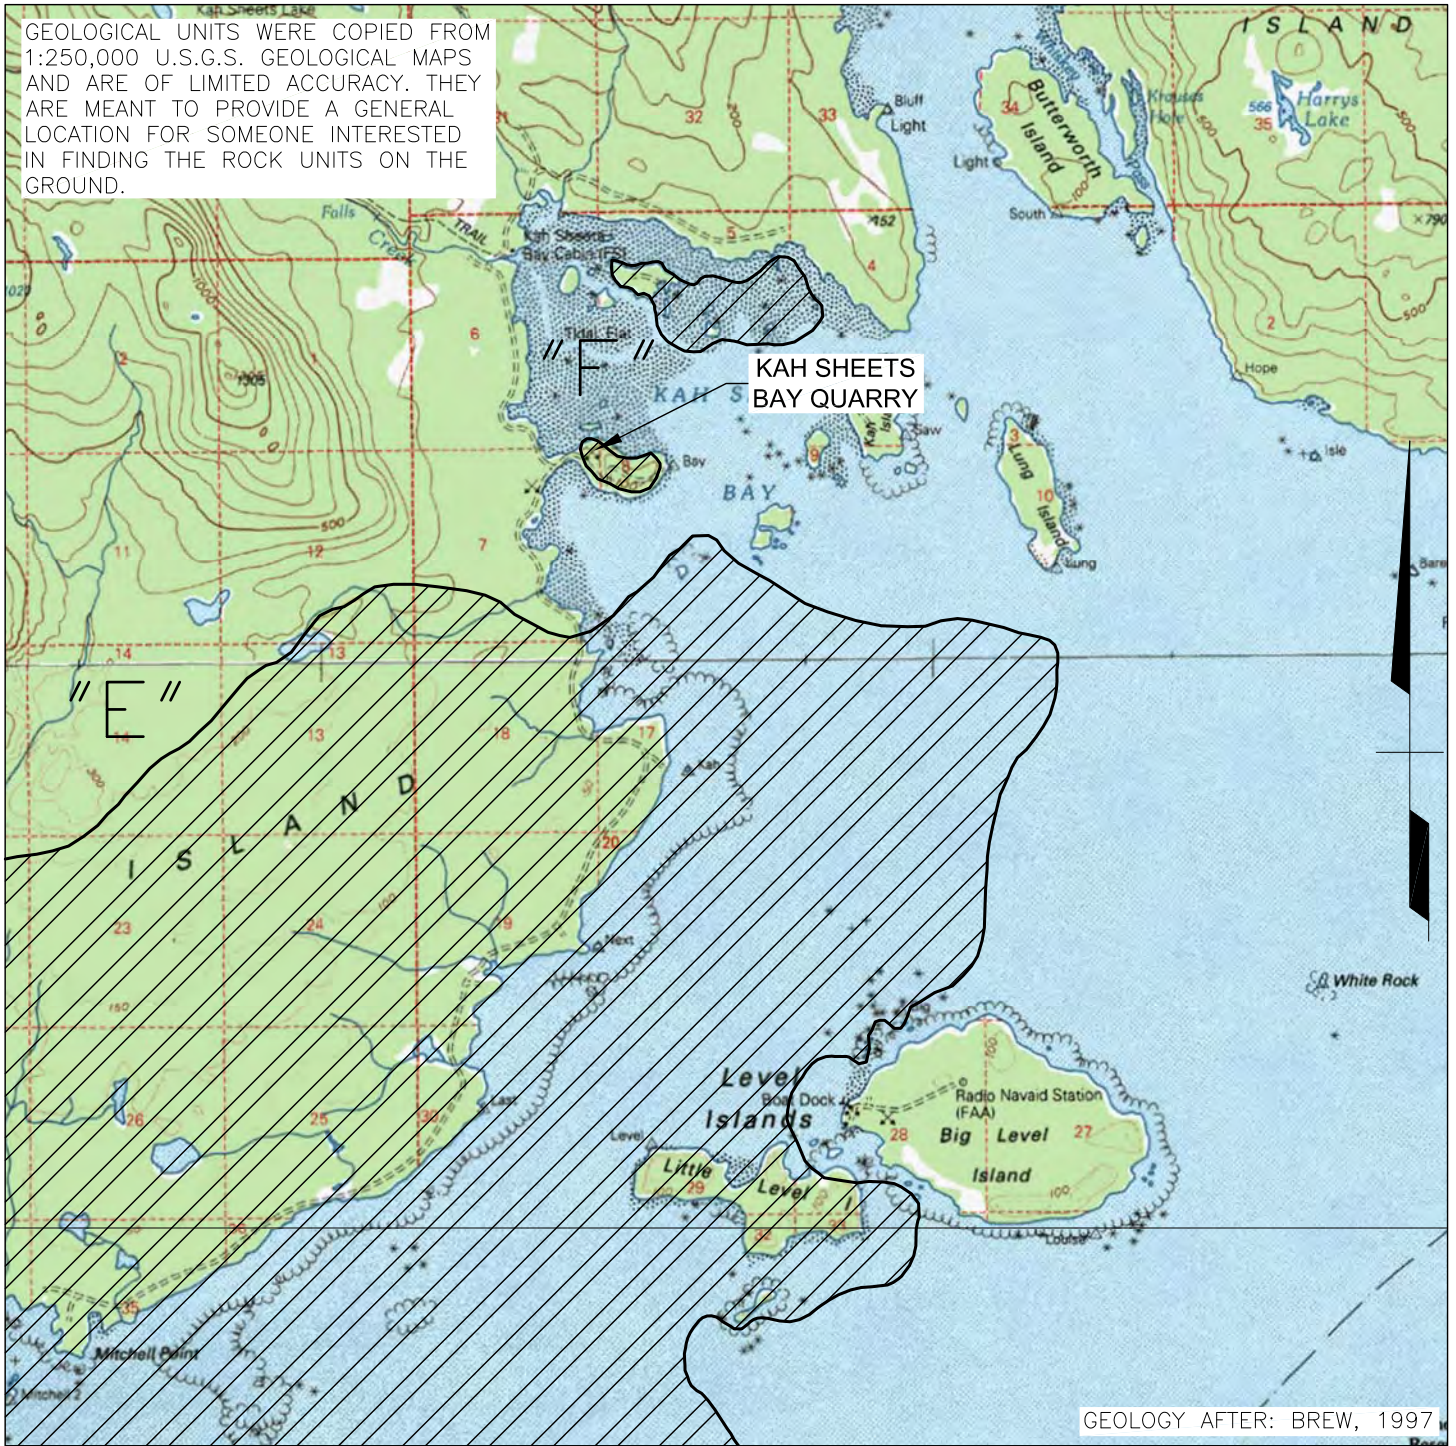
LOCATION MAP (HA-E6)

GEOLOGICAL UNITS WERE COPIED FROM 1:250,000 U.S.G.S. GEOLOGICAL MAPS AND ARE OF LIMITED ACCURACY. THEY ARE MEANT TO PROVIDE A GENERAL LOCATION FOR SOMEONE INTERESTED IN FINDING THE ROCK UNITS ON THE GROUND.

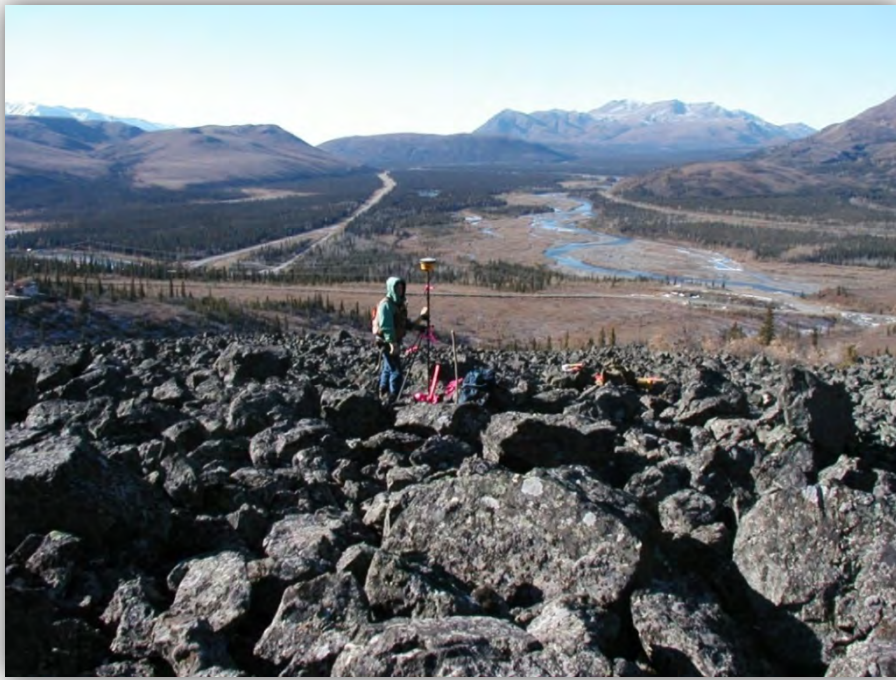
GEOLOGICAL UNITS WERE COPIED FROM 1:250,000 U.S.G.S. GEOLOGICAL MAPS AND ARE OF LIMITED ACCURACY. THEY ARE MEANT TO PROVIDE A GENERAL LOCATION FOR SOMEONE INTERESTED IN FINDING THE ROCK UNITS ON THE GROUND.

Boulders on the surface of the Cantwell Hard Aggregate Site at Control Point 3 (2003).

The following information is based on a brief field reconnaissance by R&M Consultants, Inc. conducted in September 2012 and data acquired by DOT&PF during field programs between 1996 and 2003. Site photographs are provided as Figure 2.

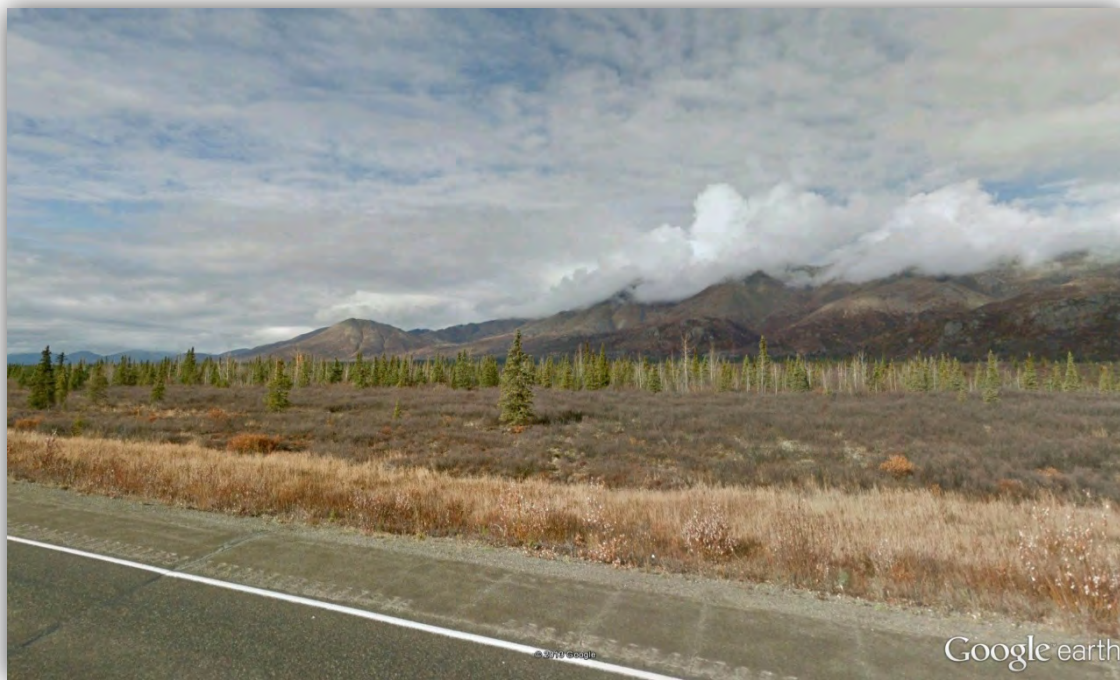
**FIGURE 5
PHOTOGRAPH OF POTENTIAL LOADING AREA
AT PARKS HIGHWAY MP 204**

Looking West toward Potential Stockpiling/Loading Site in the Trees (Google Earth, 9/2011).

3. A third loading option is approximately 12.7 miles to the south near a point where the railroad crosses the Parks Highway at MP 204 (Plate 1-C). The surrounding land is apparently owned and managed by the Ahtna/Yedatene NA Corporation (Cantwell). This location would require the construction of access roads, stockpile area, loading facility and a railroad siding. A photograph of the area is included as Figure 5.

There is an area adjacent to Parks Highway Milepost 204 which could provide a potential location for a siding and stockpile area to be developed. As part of the evaluation of this location we assumed a 4-acre parcel of land would be purchased or leased. The access roads and necessary improvements required would be made to the area to allow for stockpiling of the materials and to construct a siding of at least 1 mile in length. We anticipate utilizing materials from the Cantwell source to level the site and develop a pad for stockpiling pay materials prior to loading onto the railcars. The total anticipated cost to develop this site to the point it would be useable for stockpiling and loading would be on the order of \$4,094,000.

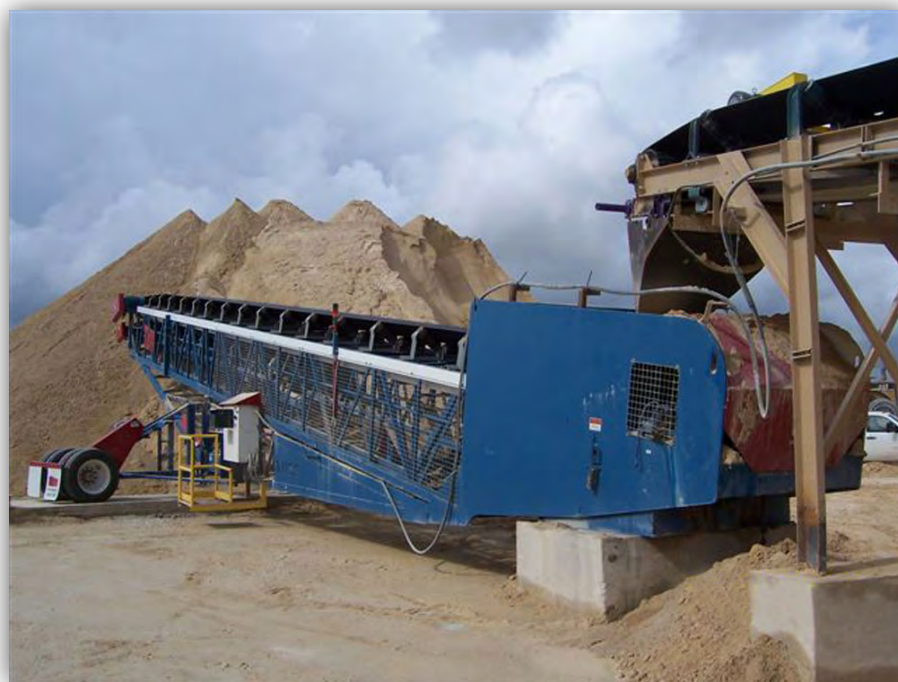
**FIGURE 6
EXAMPLE CONVEYOR LOADER/STACKER**

A hopper would be placed at one end for loaders to feed the belt.

An estimate was obtained from Thor Global for a conveyor with an inline scale that will provide the capacity needed to load the train in the time allotted. The same belt system would be used at either location.

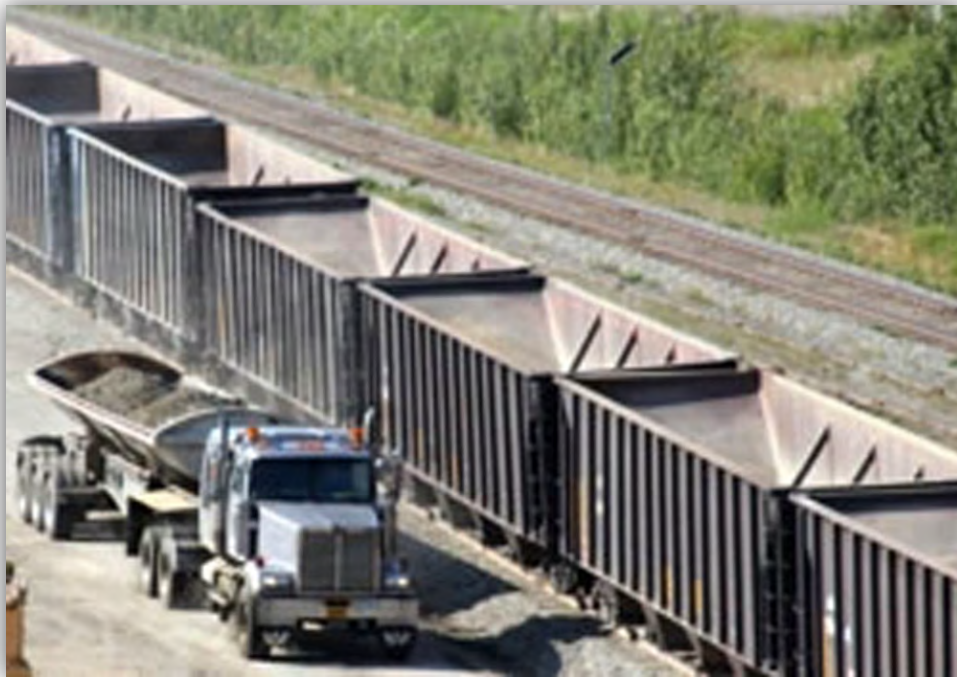
**FIGURE 7
ALASKA RAILROAD HOPPER CARS**

For the purpose of this portion of the study, we are assuming that the aggregate will be hauled to Anchorage in existing gravel trains consisting of two engines on each end with 86 gravel hopper cars between. Trains will be scheduled at the Alaska Railroad's convenience, thus allowing the Alaska Railroad to incorporate the aggregate trains into its gravel train schedule. Each gravel hopper is capable of hauling 100 tons of aggregate. Assuming that consideration will be taken to avoid overloading a hopper, we utilized 95 tons per car in our cost estimations. Figure 7 includes a photograph of Alaska Railroad's hopper cars.

Based on an assumed 126 pounds per cubic foot for the crushed aggregate, each car would contain approximately 60 cubic yards of material and thus each train would hold approximately 5,160 cubic yards of aggregate.

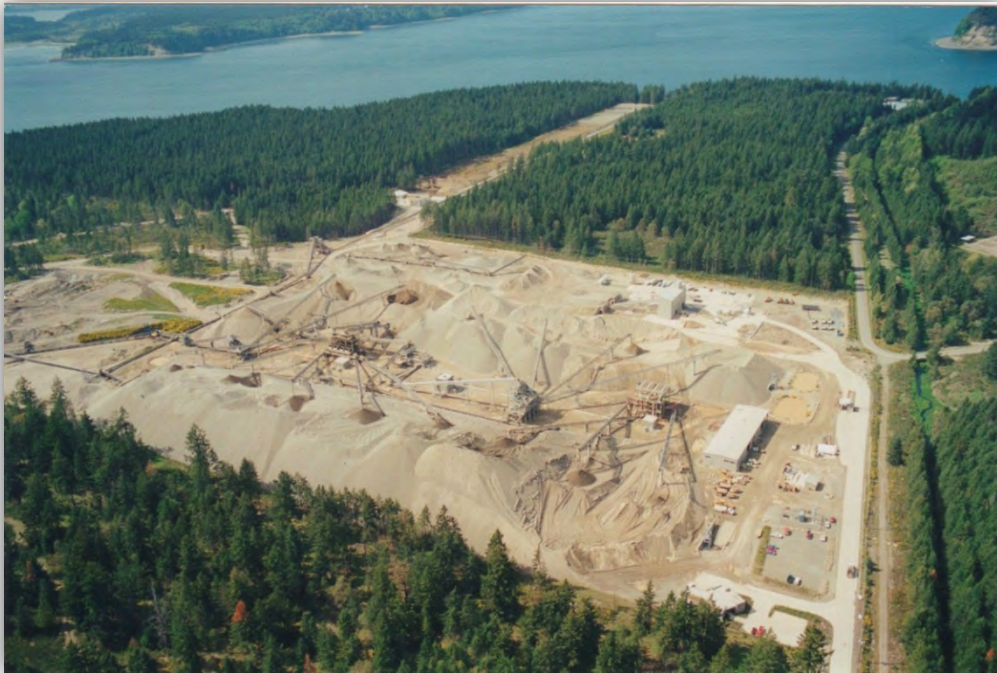
**FIGURE 9
CALPORTLAND PIONEER AGGREGATE PLANT**

The CalPortland DuPont Pioneer Aggregate Plant (Figure 9) is a large commercial aggregate site in DuPont, Washington. DOT&PF (Pavey et al., 2012) has records showing Nordic abrasion values ranging from 6.1 to 19 for the site.

The DuPont operation is one of the largest sand and gravel operations in the United States, and is a major source for building material in Washington State. Seven miles of conveyors move material around the site and out to a barge loading dock, from where most of the material is shipped to customers. Gravel from this operation was quoted at a per ton cost of \$10.98 which includes a \$1.00 per ton Environmental Compliance Charge.

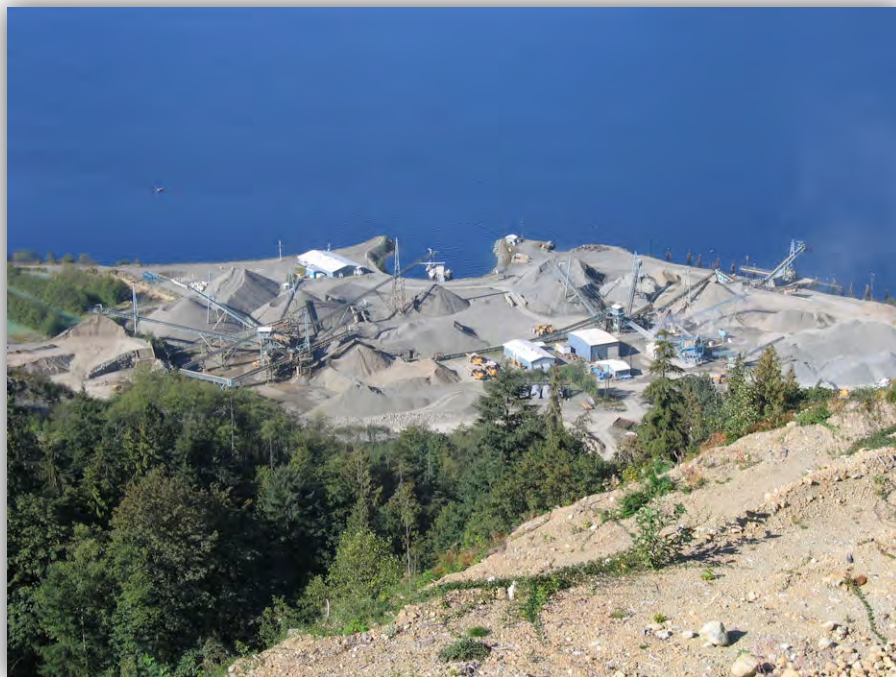
FIGURE 10
JACK CEWE LTD. SITE ON JERVIS INLET

Jack Cewe Ltd. of Coquitlam, British Columbia maintains a bedrock quarry on the southeast shore of Jervis Inlet in British Columbia, Canada (Figure 10). The rock is reportedly a granitic rock. DOT&PF (Pavey et al., 2012) has records showing Nordic abrasion values ranging from 6.9 to 9.9 for the site.

Cewe's quoted cost was \$9.50 per ton. Jack Cewe Ltd.'s submittal included estimated barging costs from Western Towboat for a 9,500-ton barge at a unit rate of \$33.34 per ton delivered to the Port of Anchorage.
